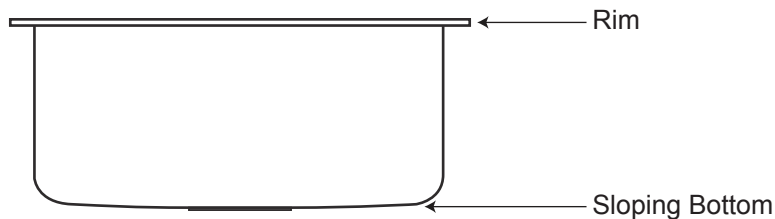
To correct a high spot or minor dent, apply pressure using the heel of the hand or lightly tapping the area with a rubber mallet. A bent rim may be corrected by placing the sink upside down on a solid, level surface and gently tapping with the mallet. Rest assured that steps taken to remove a dent in a copper sink will not void its warranty.
